# DRAFT BASIC ASSESSMENT REPORT FOR THE CONSTRUCTION OF RETHUSHENG SPECIAL SCHOOL, ON THE REMAINING EXTENT OF FARM CROMFORD 690-LR, BLOUBERG LOCAL MUNICIPALITY, LIMPOPO

Prepared for IDC Architects on behalf of the Limpopo Department of Public Works, Roads and Infrastructure (LDPWR&I).

OCTOBER 2025

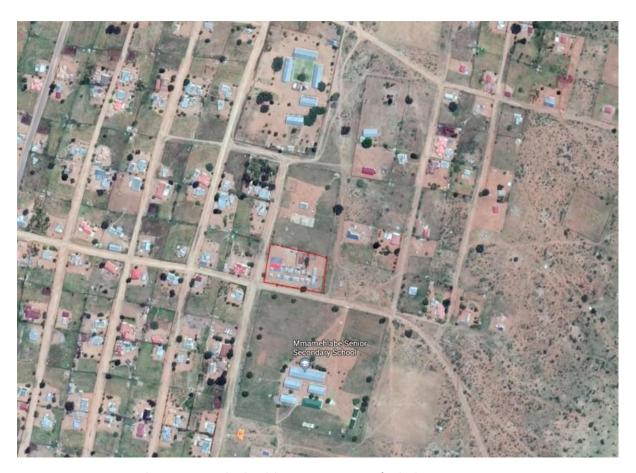
Figure 12: Existing Rethuseng Special School (current temporary facility)

At present not enough facilities for education are being constructed compared to the increasing new numbers of learners on the existing Rethuseng Special School located on the temporary structures (See **Figure 12** below) within the Mamehlabe Village. The current school located in within the rural Mamahlabe community do not have the normal facilities of flushing and clean ablutions, safety while at the learning institutions, availability to internet communication facilities, lighting and the worst food. Because of the above, there is a need to have a construction of the Rethuseng Special school in a more permanent conducive facility in a ideal location, which is what this project seek to achieve.

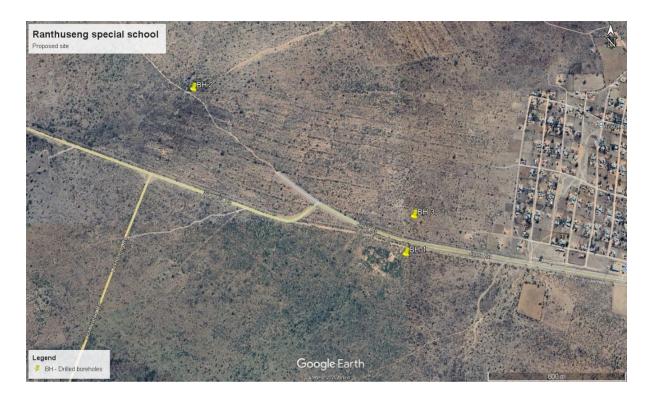
Figure 14: New drilled boreholes within the proposed site

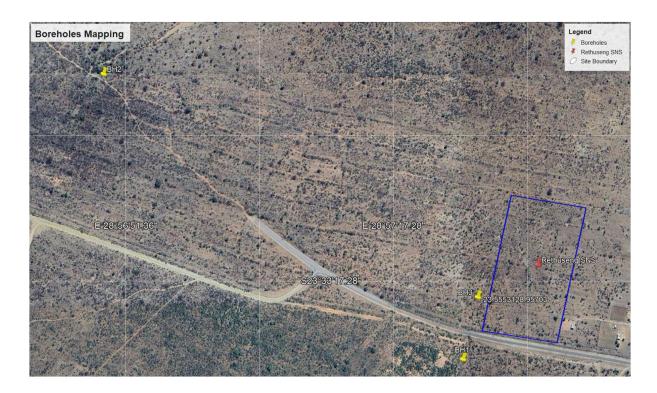
Borehole No.	Coordinates	Yield (l/s)	Duty cycle (hours)	Daily abstraction (kl/day)	Borehole depth (m)
BH1	-23.55531 28.95703	0.5	12hrs	21.5	100
BH2	-23.55684 28.95663	0.5	12hrs	21.5	120
ВН3	-23.55685 28.95663	Dry	-	-	-
	TOTAL	1		43

Figure 15: Boreholes Mapping

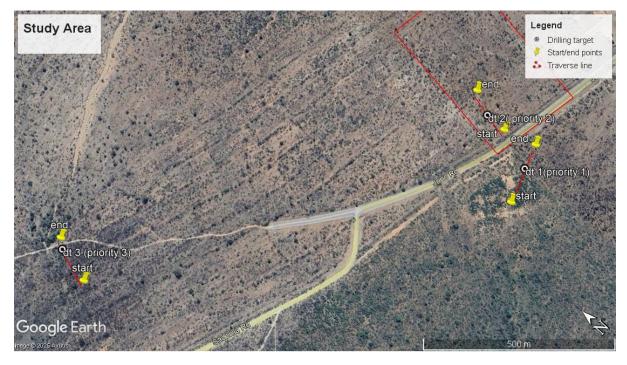
A magnetic survey is a geophysical method used to investigate the subsurface conditions. The purpose of a magnetic survey is to investigate subsurface geology based on the anomalies in the Earth's magnetic field resulting from the magnetic properties of the underlying rocks. The magnetic survey was undertaken perpendicular to the geological structures of the area of interest. Ten-meter intervals were used to record the Earth's magnetic field intensity.

Figure 30: Traverse line 1 – 3 and drilling targets

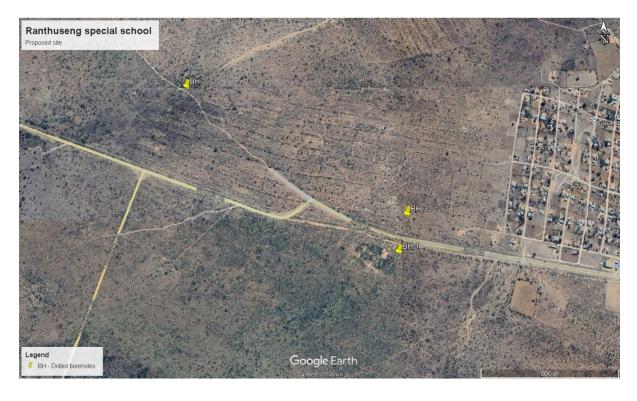
Three boreholes were drilled from August 23 to 26, 2025. Different Lithologies were encountered during the drilling process, including silty topsoil and coarse-grained biotite gneiss. Water strikes were encountered at 30, 60, and 90 m deep in boreholes 1 and 2. Drilled **borehole 1** was stopped at 120 m, while **borehole 2** was stopped at 100 m deep. The newly drilled borehole locality is shown in **Figure 10** below.

Figure 31: New drilled boreholes within the proposed site
