**GEOHYDROLOGICAL REPORT FOR THE PROPOSED RETHUSHENG  
SNS SCHOOL AT MAMEHLABE VILLAGE, POLOKWANE LOCAL  
MUNICIPALITY, IN LIMPOPO PROVINCE.**

**Draft Report**

**NALEDZI WATERWORKS (PTY) LTD**

***03 September 2025***

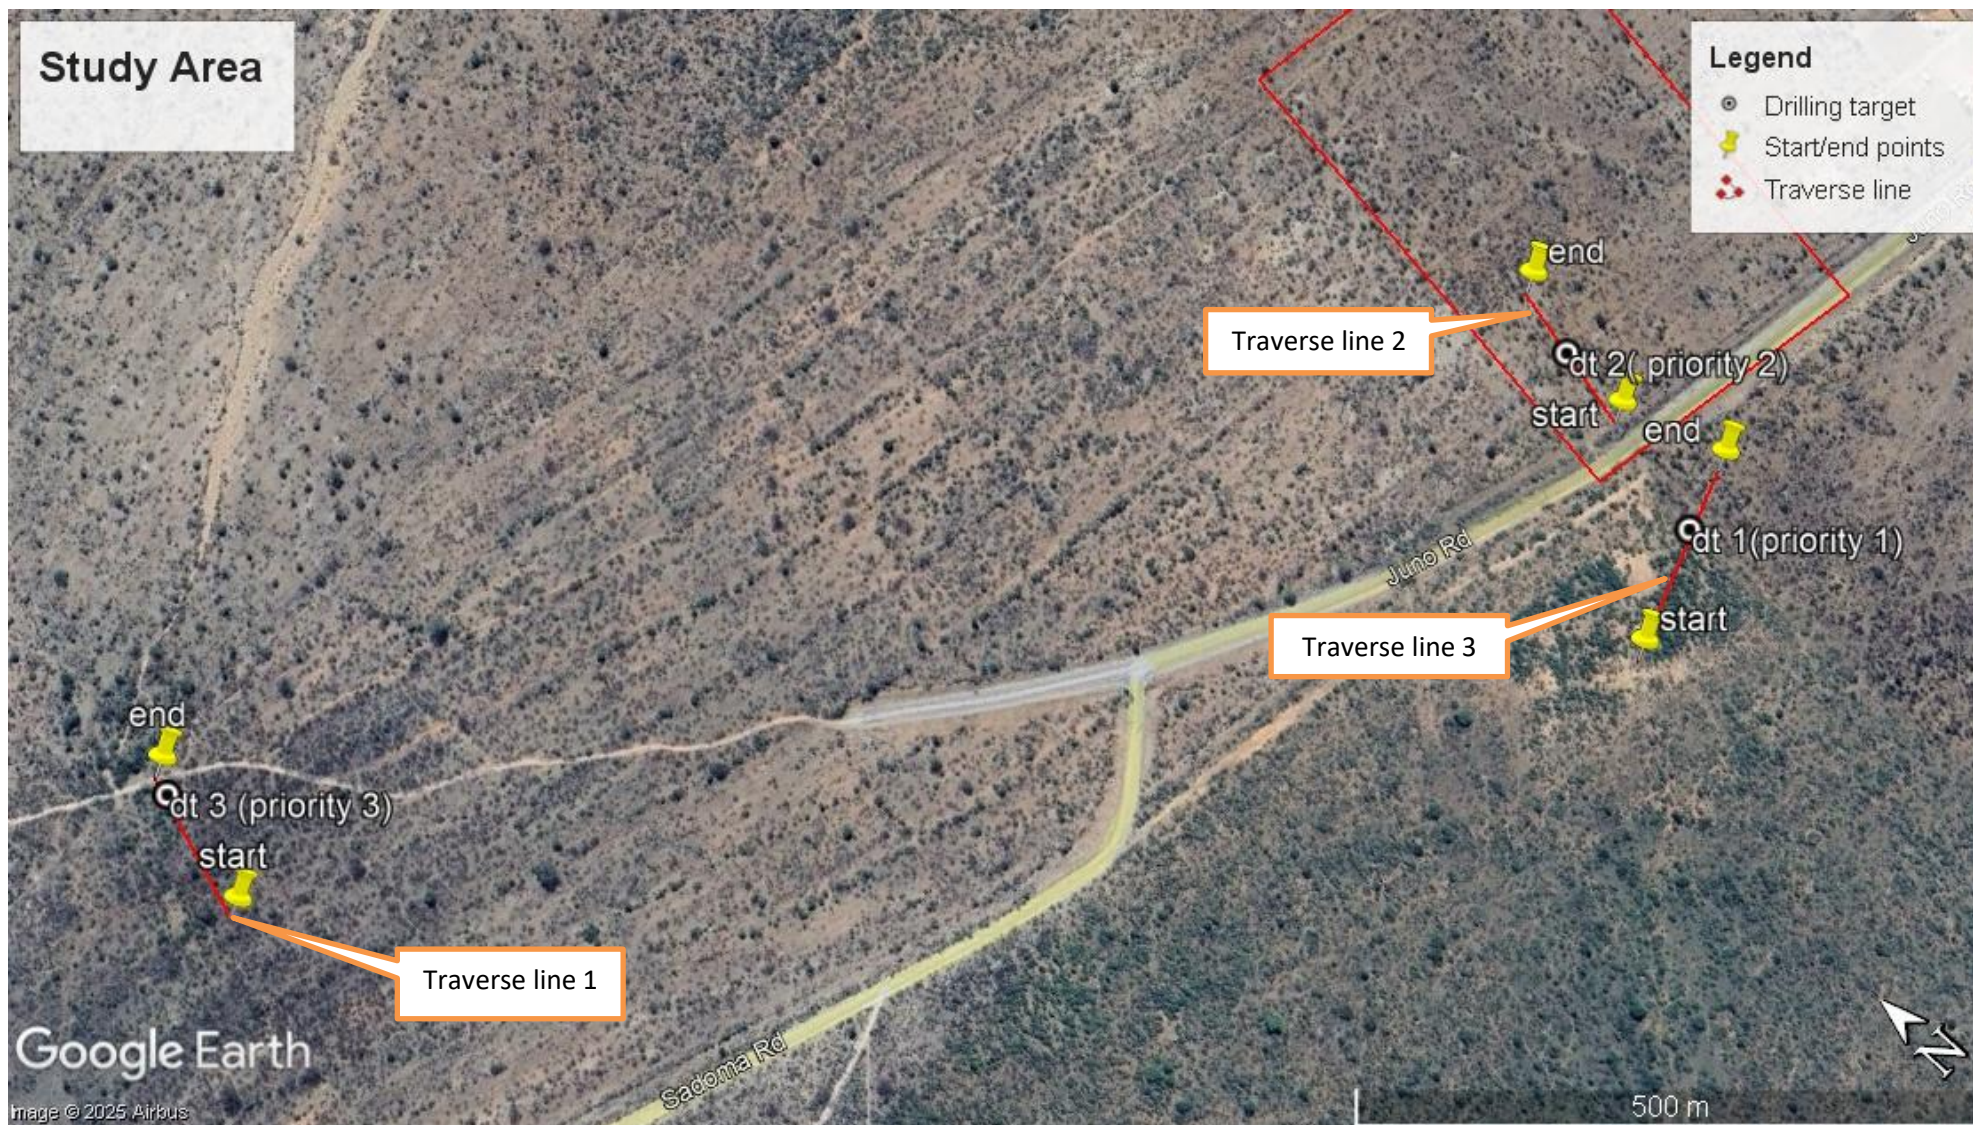
**Figure 3: Traverse line 1 – 3 and drilling targets**

A magnetic survey is a geophysical method used to investigate the subsurface conditions. The purpose of a magnetic survey is to investigate subsurface geology based on the anomalies in the Earth's magnetic field resulting from the magnetic properties of the underlying rocks. The magnetic survey was undertaken perpendicular to the geological structures of the area of interest. Ten-meter intervals were used to record the Earth's magnetic field intensity; magnetic results are shown in Figures 5, 7, and 9.

**Table 1: Drilling Targets**

| Target (T) and Traverse line (T) | Coordinates | Possible water-bearing structures in metres | Maximum borehole depth estimation in metres |
| <b>T<sub>1</sub>, T<sub>3</sub></b> (Priority 1) | -23.55684°, 28.95663° | <b>25 40, 50, 70, 90, 110, 120 m</b> | <b>150 m deep</b> |
| <b>T<sub>3</sub>, T<sub>1</sub></b> (Priority 3) | -23.55531°, 28.95703° | <b>30, 50, 80, 95, 110, 130 m</b> | <b>150 m deep</b> |
| <b>T<sub>2</sub>, T<sub>2</sub></b> (Priority 2) | -23.54980°, 28.94692° | <b>30, 40, 55, 70, 90, 110 m</b> | <b>120 m deep</b> |

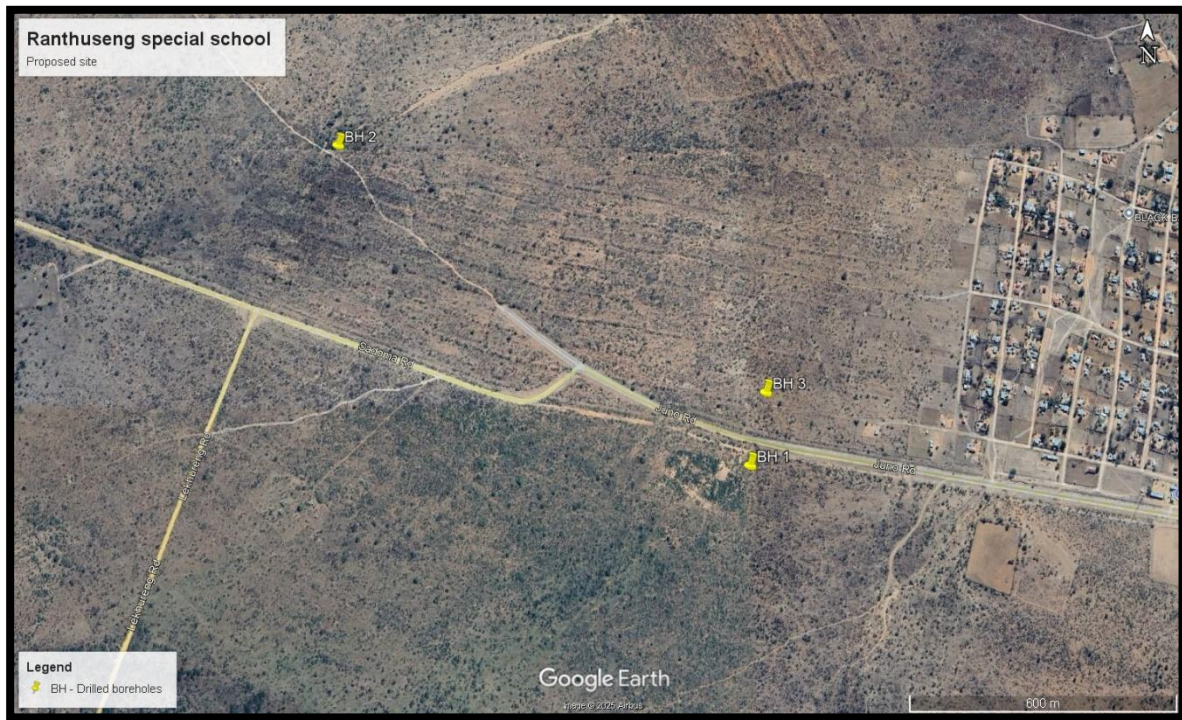
**Figure 10: New drilled boreholes within the proposed site**

Three boreholes were drilled from August 23 to 26, 2025. Different Lithologies were encountered during the drilling process, including silty topsoil and coarse-grained biotite gneiss. Water strikes were encountered at 30, 60, and 90 m deep in boreholes 1 and 2. Drilled **borehole 1** was stopped at 120 m, while **borehole 2** was stopped at 100 m deep. The newly drilled borehole locality is shown in Figure 10 below.
