GEOTECHNICAL INVESTIGATION REPORT FOR THE DESIGN AND CONSTRUCTION OF RETHUSENG SPECIAL SCHOOL, MAMEHLABE, BLOUBERG LOCAL MUNICIPALITY, CAPRICORN DISTRICT, LIMPOPO PROVINCE.

Report Number: LDPWRI-PROF/16003/A.rev00

28 August 2025

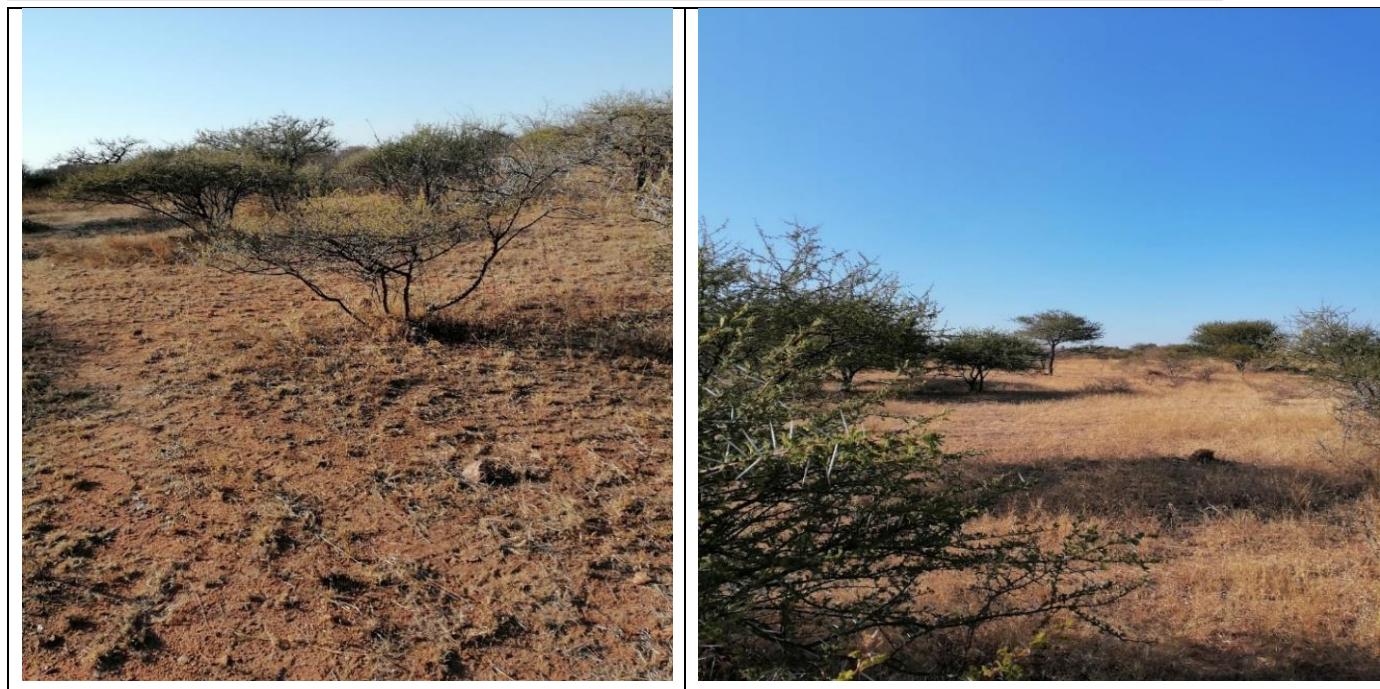
Plate 1: Condition of the site

The site is currently vacant and classified as a greenfield area. It is predominantly covered with natural vegetation, including trees and dense shrubbery. **Plate 1** shows the condition of the site.

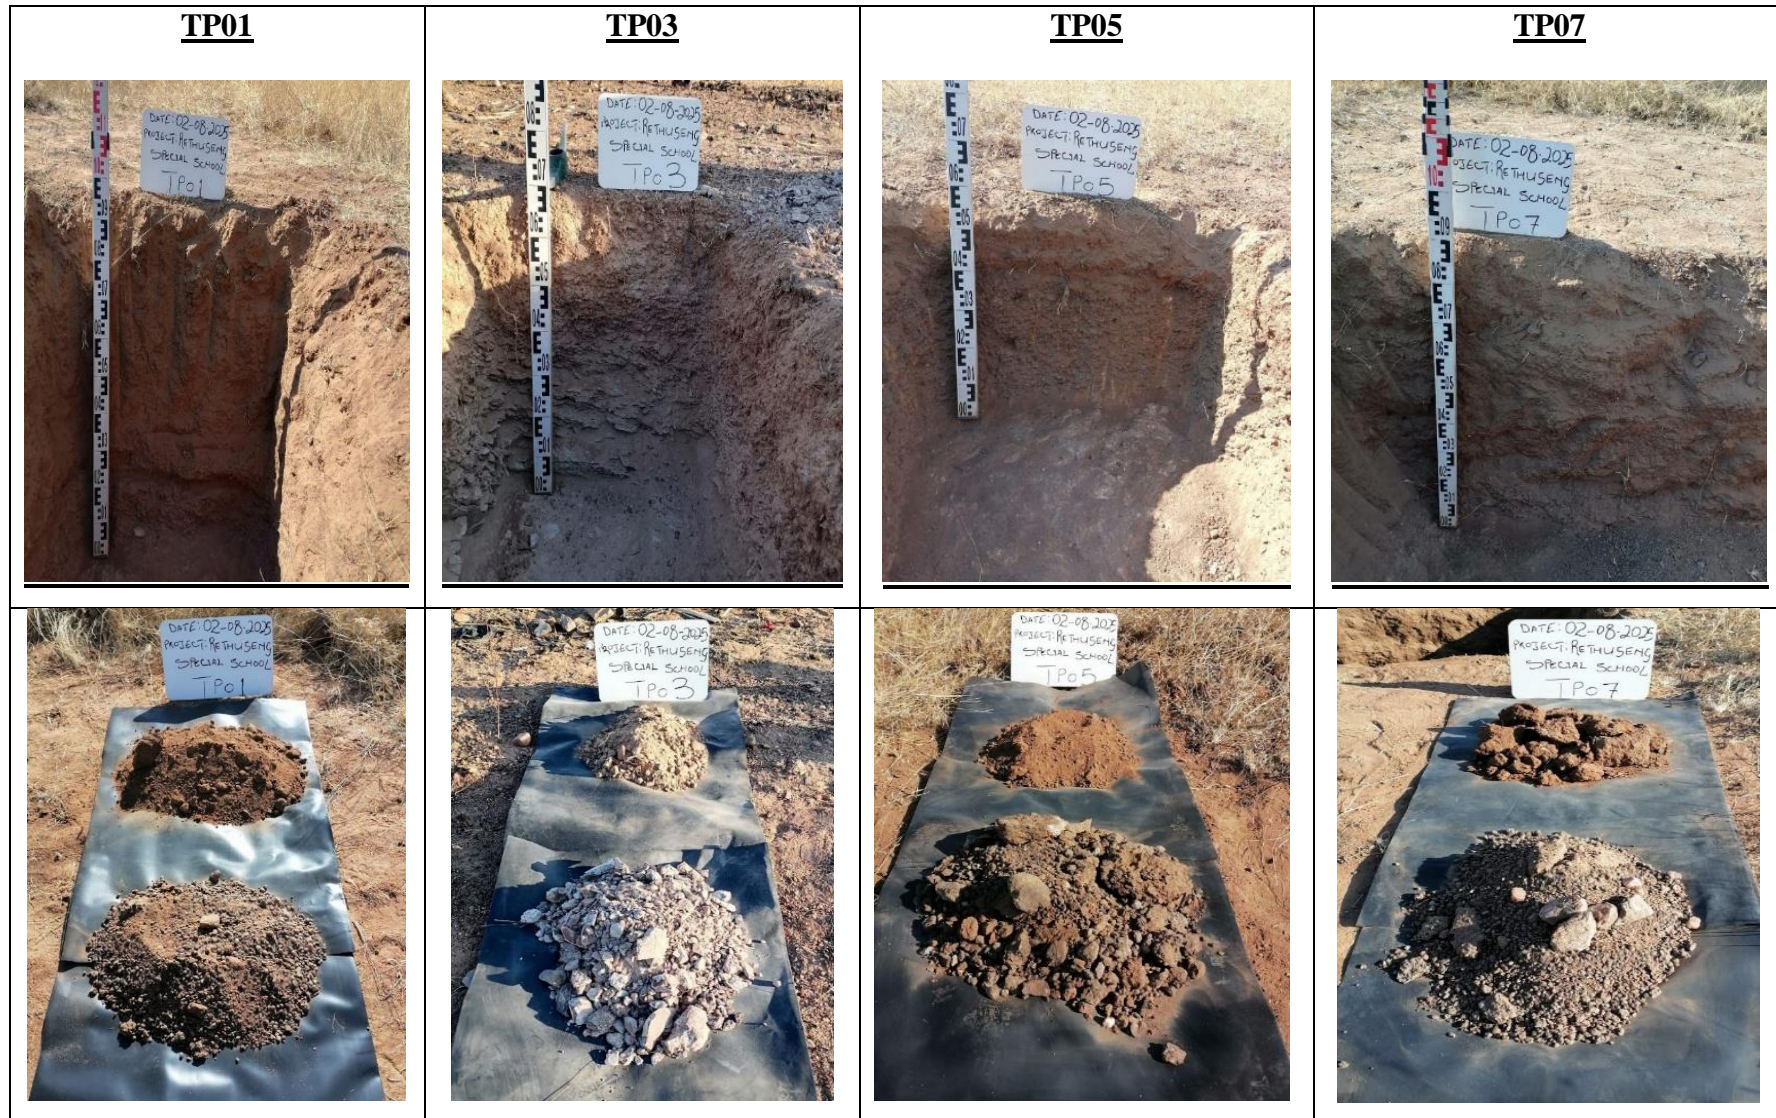
Plate 2: Typical soil horizons encountered on site

Weathered Bedrock Granite

Light reddish brown speckled black, moderately weathered, medium grained, fractured, soft - Granite.

The site is mantled by transported soils overlying residual granite. The residual granite is underlain by weathered granite bedrock at shallow depth. The transported horizons comprise silty sandy gravel and gravelly silty sand, whereas the residual profile is predominantly granitic gravelly sand to sandy gravel.

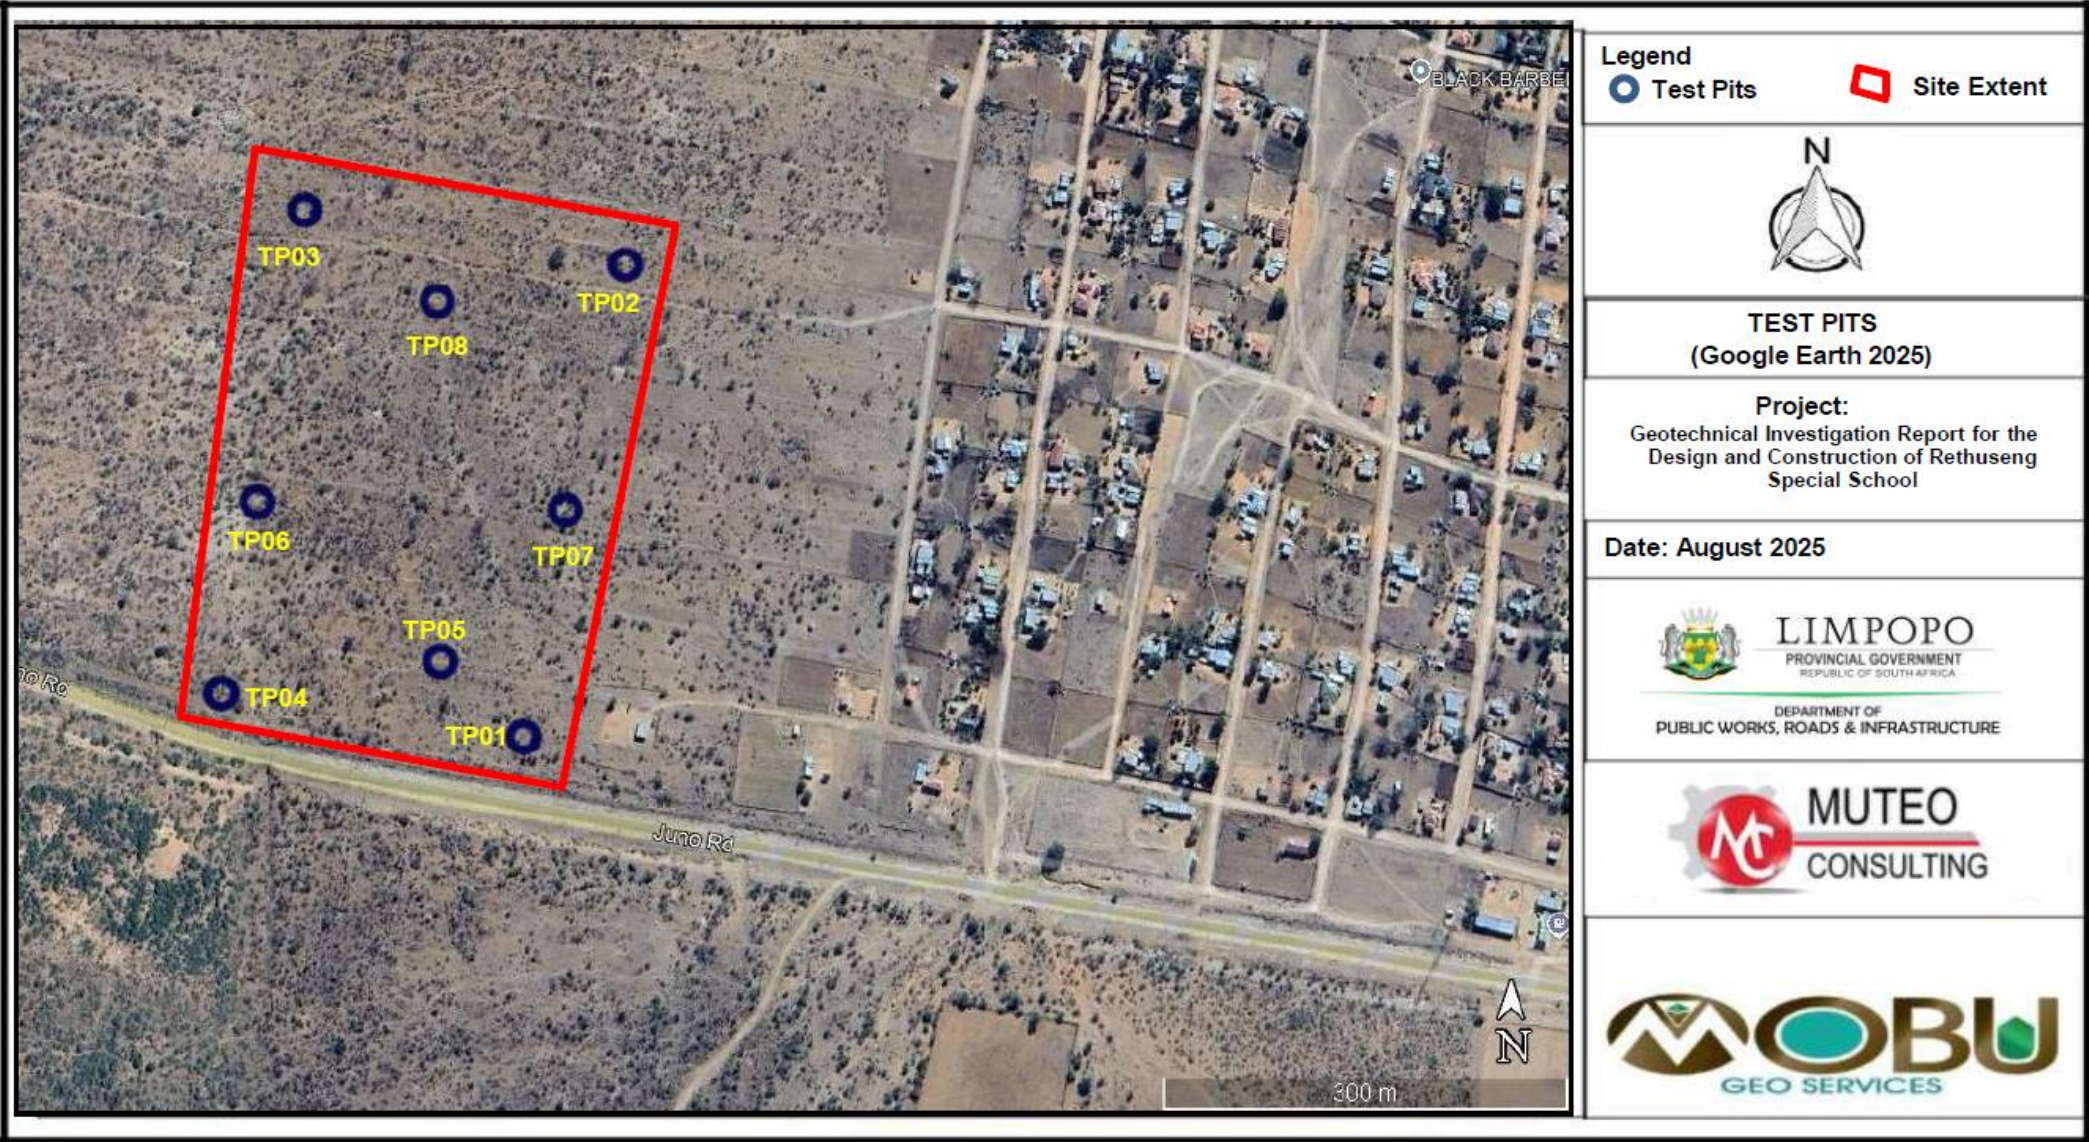
Figure 3: Test Pits Layout Map

Fieldwork was conducted on the 2nd of August 2025 and comprised excavation of eight (8) test pits to a maximum depth of approximately 1.05m using manual excavation. The exposed soil horizons in each of the pit were identified and described comprehensively applying the MCCSSO technique as advocated by Jennings et al (1973). The acronym: MCCSSO – stands for Moisture, Colour, Consistency, Structure, Soil Type, and Origin. The test pits were designated TP01 to TP08 and is shown on the layout drawing, **Figure 3**. The test pit coordinates, and depth of excavation are provided in **Table 1** below.

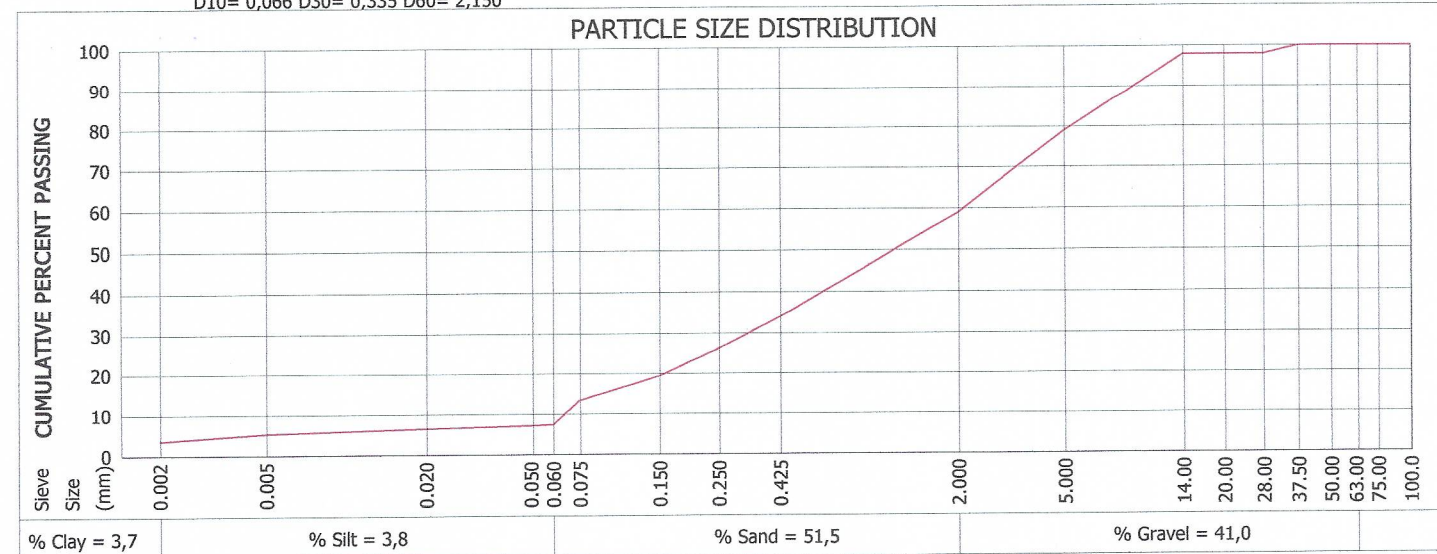
Sieve Size(mm)	% Passing			
100.0	100	Soil Mortar	2.000 - 0.425	43
75.00	100		0.425 - 0.250	13
63.00	100		0.250 - 0.150	12
50.00	100		0.150 - 0.075	11
37.50	100		< 0.075	22
28.00	98	Effective Size		0,066
20.00	98		Uniformity Coefficient	32,6
14.00	98		Curvature Coefficient	0,8
5.000	79		Oversize Index	0,0
2.000	59		Shrinkage Product	0,0
0.425	34	Grading Coefficient		30,8
0.250	26		Grading Modulus	1,90
0.150	19			
0.075	13			
0.060	7,5			
0.050	7,3	Atterberg Limits	Liquid Limit	
0.020	6,6		Plasticity Index	NP
0.005	5,4		Linear Shrinkage	0,0
0.002	3,7		PI < 0.075	8
			Unified Soil Classification	SC
			US Highway Classification	A-1-b(0)

D10= 0,066 D30= 0,335 D60= 2,150

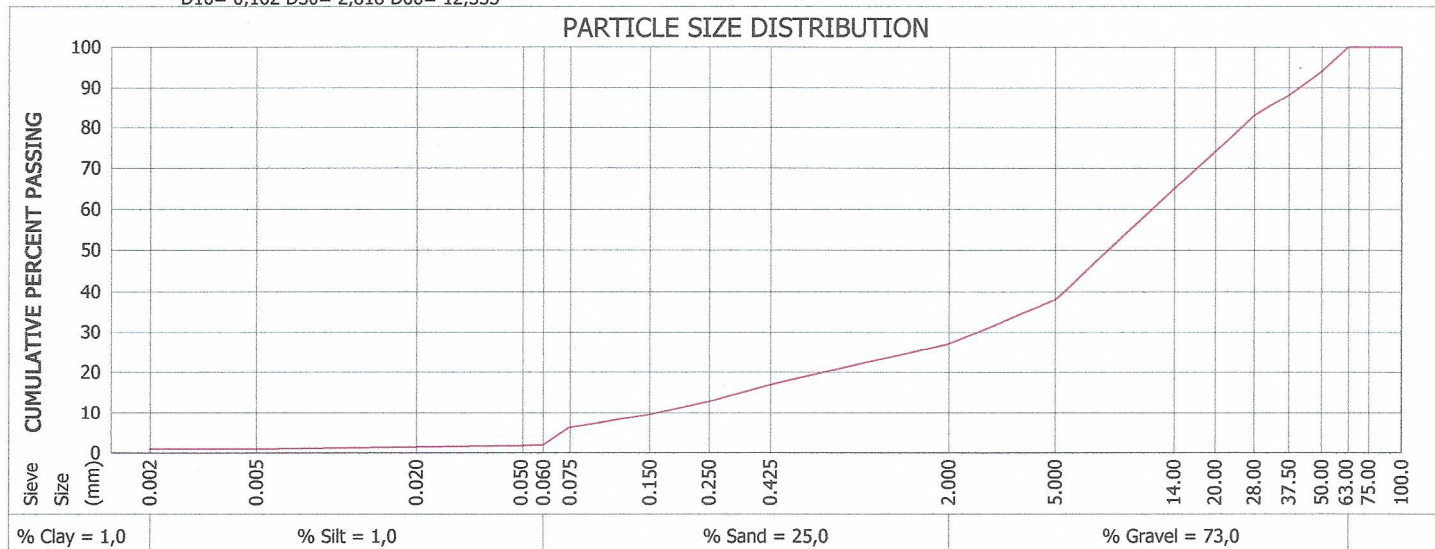
Sieve Size(mm)	% Passing	Soil Mortar	2.000 - 0.425	38
100.0	100		0.425 - 0.250	15
75.00	100		0.250 - 0.150	12
63.00	100		0.150 - 0.075	13
50.00	94		< 0.075	22
37.50	88	Effective Size		0,162
28.00	83	Uniformity Coefficient		76,1
20.00	74	Curvature Coefficient		4,0
14.00	65	Oversize Index		6,0
5.000	38	Shrinkage Product		0,0
2.000	27	Grading Coefficient		21,3
0.425	17	Grading Modulus		2,50
0.250	13	Atterberg Limits	Liquid Limit	
0.150	9,6		Plasticity Index	NP
0.075	6,3		Linear Shrinkage	0,0
0.060	2,0		PI < 0.075	5
0.050	1,9	Unified Soil Classification		GW-GC
0.020	1,6	US Highway Classification		A-1-a(0)
0.005	1,0			
0.002	1,0

D10= 0,162 D30= 2,818 D60= 12,333

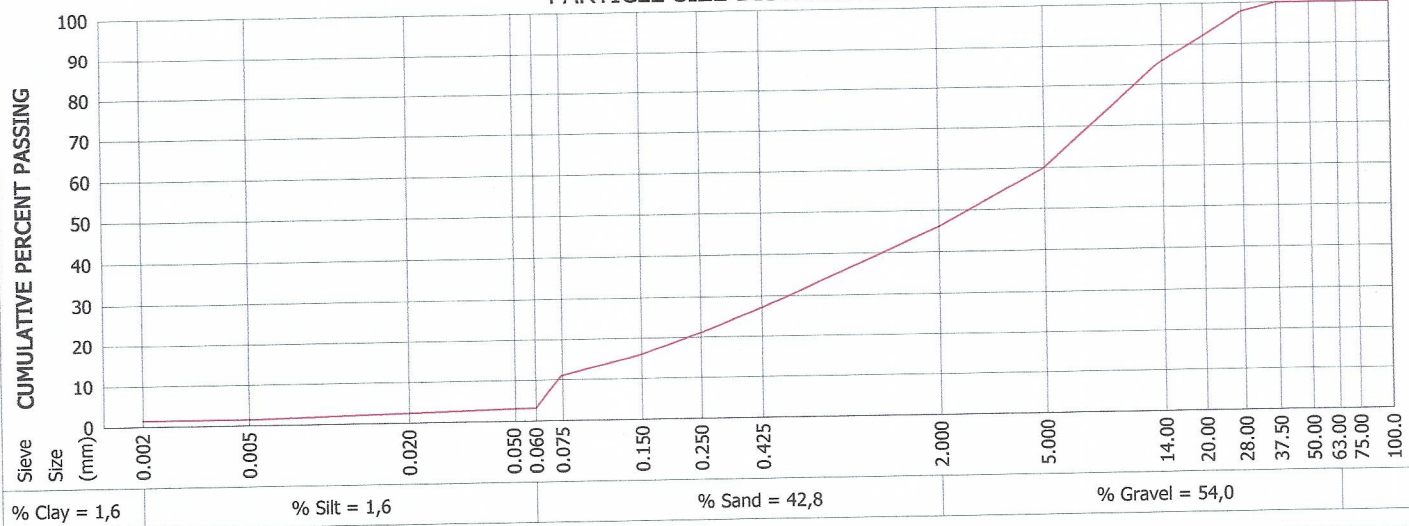
PARTICLE SIZE DISTRIBUTION

Sieve Size(mm)	% Passing	Soil Mortar	2.000 - 0.425	41
100.0	100		0.425 - 0.250	13
75.00	100		0.250 - 0.150	11
63.00	100		0.150 - 0.075	11
50.00	100		< 0.075	24
37.50	100		Effective Size	0,073
28.00	98		Uniformity Coefficient	68,5
20.00	92		Curvature Coefficient	1,2
14.00	86		Oversize Index	0,0
5.000	60		Shrinkage Product	27,0
2.000	46		Grading Coefficient	31,2
0.425	27		Grading Modulus	2,20
0.250	21			
0.150	16			
0.075	11			
0.060	3,2			
0.050	3,1			
0.020	2,5			
0.005	1,6			
0.002	1,6

D10= 0,073 D30= 0,674 D60= 5,000

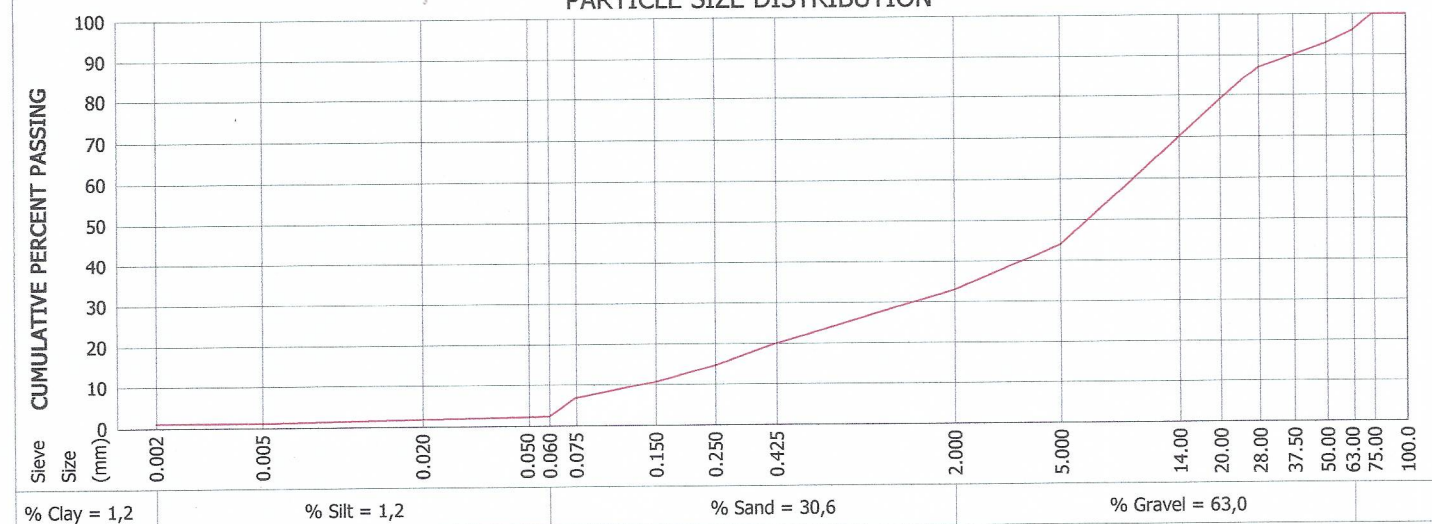
PARTICLE SIZE DISTRIBUTION

Sieve Size(mm)	% Passing	Soil Mortar	2.000 - 0.425	40
100.0	100		0.425 - 0.250	16
75.00	100		0.250 - 0.150	12
63.00	96		0.150 - 0.075	11
50.00	93		< 0.075	21
37.50	90	Effective Size		0,136
28.00	87	Uniformity Coefficient		77,5
20.00	79	Curvature Coefficient		1,9
14.00	70	Oversize Index		3,0
5.000	44	Shrinkage Product		30,0
2.000	33	Grading Coefficient		23,8
0.425	20	Grading Modulus		2,40
0.250	15	Atterberg Limits	Liquid Limit	
0.150	11		Plasticity Index	SP
0.075	6,9		Linear Shrinkage	1,5
0.060	2,4		PI < 0.075	9
0.050	2,3	Unified Soil Classification		GW-GC
0.020	1,9	US Highway Classification		A-1-a(0)
0.005	1,2			
0.002	1,2

D10= 0,136 D30= 1,637 D60= 10,538

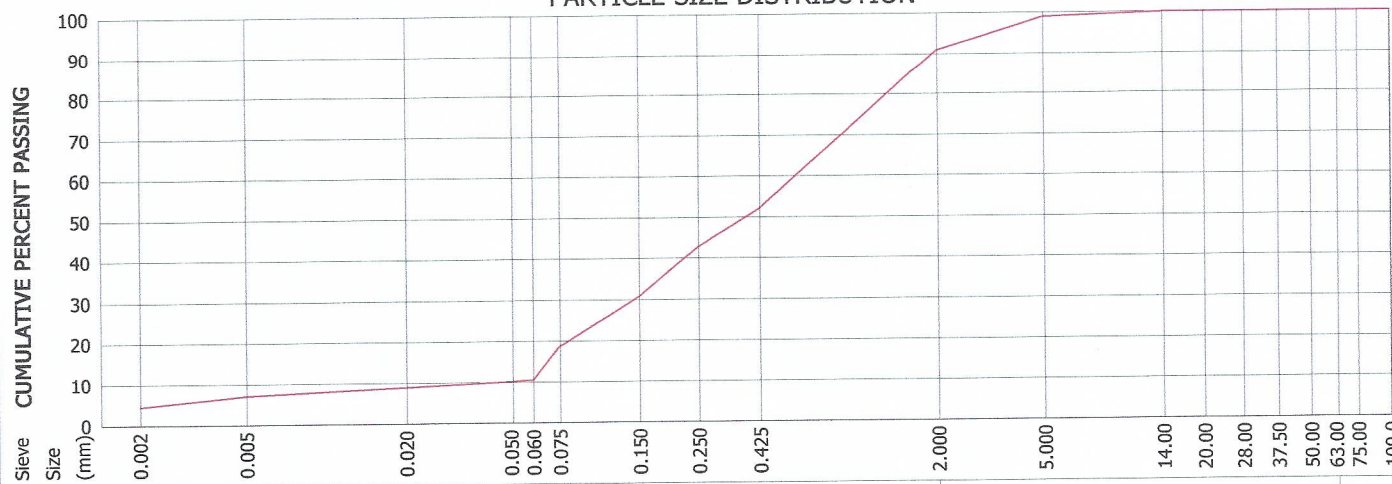
PARTICLE SIZE DISTRIBUTION

Sieve Size(mm)	% Passing	Soil Mortar		
100.0	100	2.000 - 0.425	43	
75.00	100	0.425 - 0.250	10	
63.00	100	0.250 - 0.150	13	
50.00	100	0.150 - 0.075	13	
37.50	100	< 0.075	21	
28.00	100	Effective Size	0,045	
20.00	100	Uniformity Coefficient	16,6	
14.00	100	Curvature Coefficient	0,6	
5.000	99	Oversize Index	0,0	
2.000	91	Shrinkage Product	78,0	
0.425	52	Grading Coefficient	8,9	
0.250	43	Grading Modulus	1,40	
0.150	31	Atterberg Limits		
0.075	19		Liquid Limit	
0.060	11		Plasticity Index	SP
0.050	10		Linear Shrinkage	1,5
0.020	9,0		PI < 0.075	13
0.005	7,2	Unified Soil Classification	SC	
0.002	4,6	US Highway Classification	A-2-4(0)

D10= 0,045 D30= 0,145 D60= 0,748

% Clay = 4,6 % Silt = 6,0 % Sand = 80,4 % Gravel = 9,0
